SERVICE INFORMATION

STANDARD AND TRIUMPH VEHICLES

No.	SPORTS/3/P	ACCELERATOR PEDAL MAXIMUM LIMIT STOP FOR LEFT HAND DRIVE CARS	Date	FEBRUARY 1956
------------	------------	--	-------------	---------------

No.	SPORTS/2/S	EXHAUST PIPE VIBRATION	Date	MAY 1956
-----	------------	------------------------	------	----------

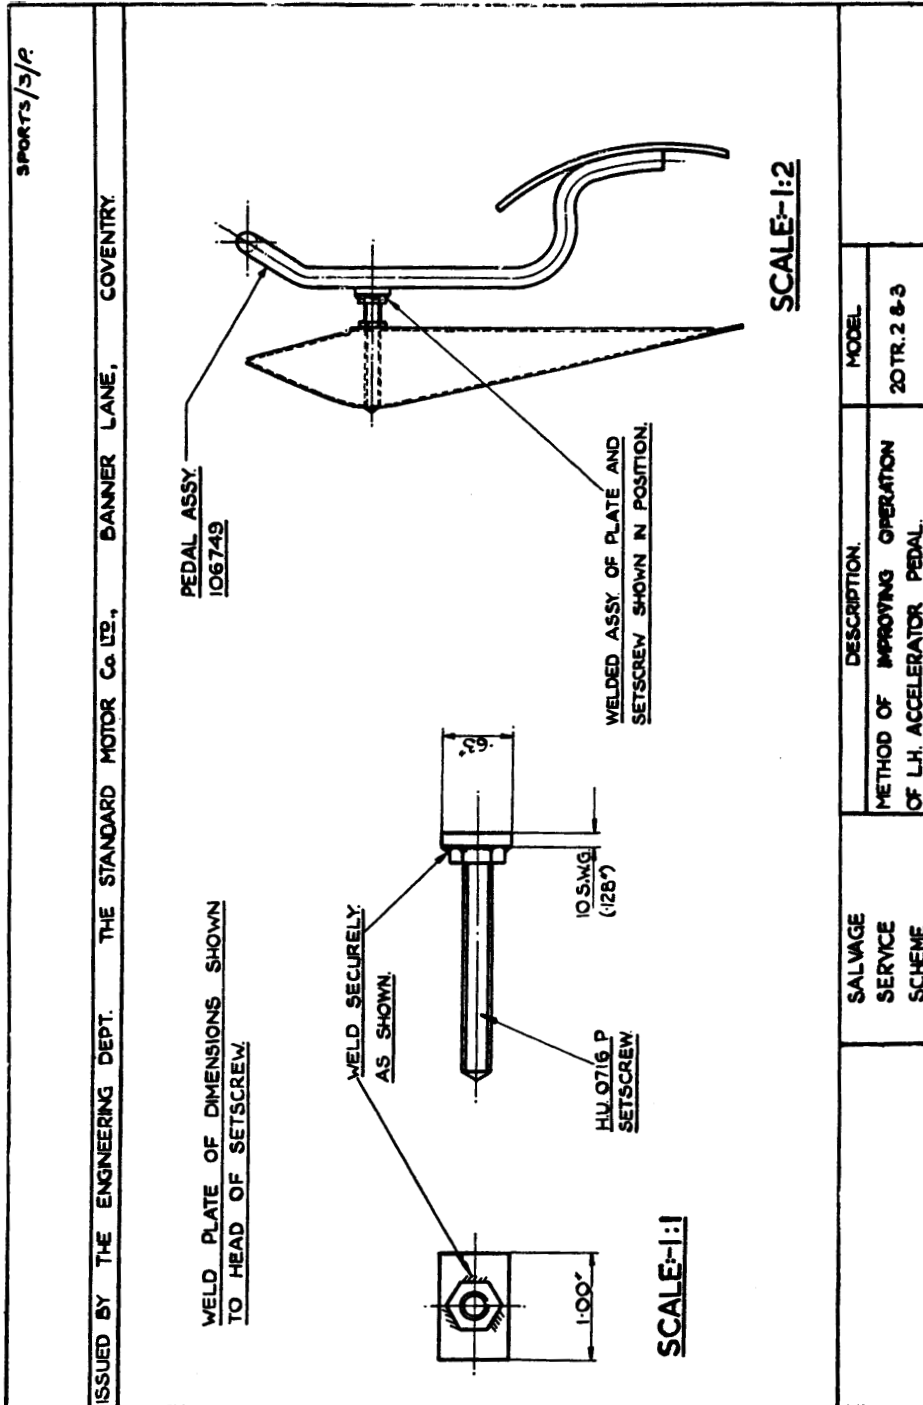
With the original design, if it is necessary to reset the accelerator pedal after a car leaves the Factory, resulting misalignment of the pedal with the stop can allow the former to pass the limit stop, thereby interfering with its free return when released.

To simplify the method of fitting a suitable stop on cars already in service, the illustration gives details for incorporating a stop plate on the limit stop screw, which is already fitted in the dash panel.

Care should be taken that the stop plate is adjusted after fitting so that its 1" side is horizontally positioned.

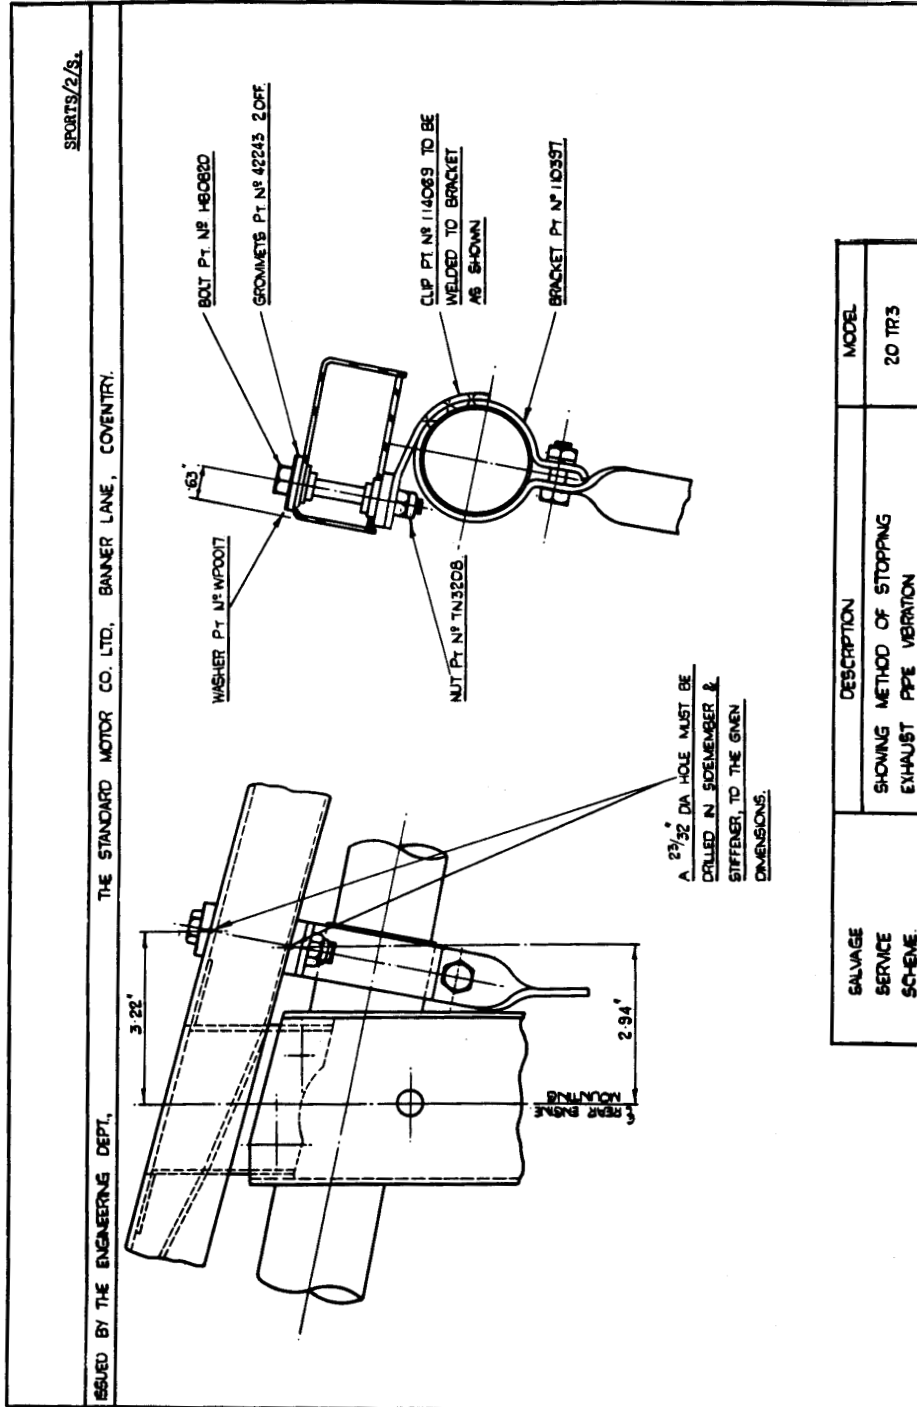
If an exhaust pipe vibration, which is not infrequently thought to be an engine vibration, is experienced at 2000-2500 r.p.m. the forward exhaust pipe mounting can be modified as shown in the illustration. The following parts are affected by this change:

It will be seen from the parts affected that the flexible mounting strip supporting the original bracket, Part.No. 110397, in a vertical plane has been deleted.

The original mounting used on the L.H. section of the cruciform, which supports the front pipe bracket, remains unchanged. The new mounting, which is an identical assembly to the latter, is used to support the R.H.S.of the bracket and is attached to the R.H. section of the cruciform.
